## Project Profile: Alsip Public Works

*A tough new Concare flooring system breathes new life into this public works garage.*

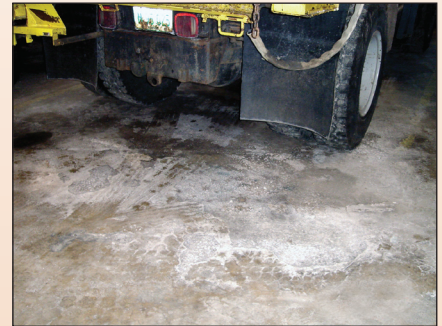
In the Alsip Public Works garage, the concrete was so deteriorated from years of grease, salt, and other contaminants that the top 1/4" of the slab had been totally eaten away in many places. The worn surface was nearly impossible to clean, and public works employees were discouraged from even trying. The garage was dark, unappealing, and the protective sealer that had long-ago been applied was rapidly vanishing.

Years of salt, grease and grime had taken their toll on the concrete at Alsip Public Works.

When Concare finally returned to Alsip Public Works, the plan was to apply a GuardRight™ EC resurfacer in the high-traffic areas, and economize with CoatRight™ UC elsewhere. As the existing surface was being prepared, Concare's management discovered that the concrete was much more deteriorated than anyone had realized. Crews were faced with a post-prep condition that demanded the installation of a GuardRight™ EC system throughout the facility.

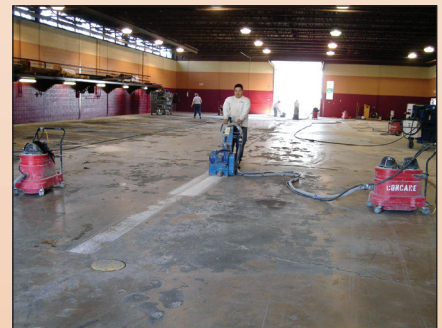
A Concare team member uses a scarifier during the preparation phase.

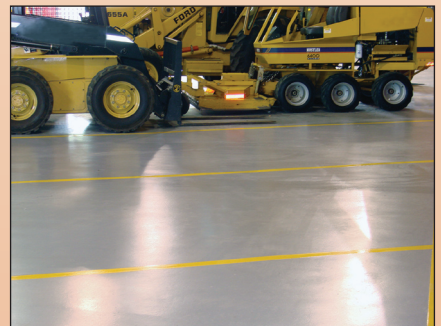
Tough, safe new flooring brought new life to the Alsip Public Works garage.
