A Tall Order: Giraffe Enclosure Overhaul

Giraffe Enclosure Overhaul

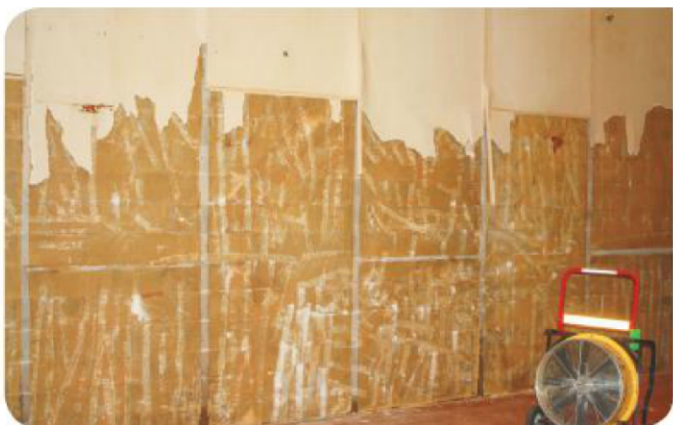
The walls' fiberglass panels (FRP) were deteriorating and needed to be redone. The plan was to use a four-stage coating system, which included a more viscous material than on the floors. But first: prep!

cleaned and did not encourage the growth of bacteria. However, there was one major problem: The giraffes were able to break the FRP. That meant that it was beginning to chip off.

"The FRP served its purpose until the panels began to deteriorate. Like most animals, giraffes are naturally curious, and over time, they figured out that they could gnaw at the wall covering. This created not only a situation where the walls were no longer sanitary, but it also meant that the giraffes could ingest the chips of FRP," explained Puszynski.

Concare and PIP knew that the panels must be removed and replaced with a system that did not pose the same health hazard to the animals. "We proposed that all panels and the glue underneath be removed so that the concrete block wall was exposed. Once the exposed concrete was clean, we proposed the application of PIP's seamless, antimicrobial coating system," stated Puszynski.

The six-man crew used Metabo 7-inch (17.8 cm), handheld diamond grinders to prepare the surface and remove all mastic and adhesive on the 5,620 square feet (522.1 m²) of wall area. The surface preparation was very labor intensive, as the crew was holding the 15- to 17-pound (6.8–7.7 kg) grinders against a vertical surface. “The surface prep took a significant amount of time. We needed to make sure to remove all remnants of the adhesive and create a uniform surface for the application of the pretreatment material,” stated Puszynski.

The pretreatment material used was PIP’s Protect AM-PT-BW, a single-component antimicrobial penetrant that is designed to create a moisture barrier. The material forms a colloidal gel that is antifungal and antimicrobial and penetrates 2 to 4 inches (5.1–10.2 cm) into the substrate. According to the PIP technical data sheet, Protect AM-PT-BW penetrates the concrete substrate and reacts with free alkali and/or alkaline hydrates, internally producing an extremely dense silica hydro-gel with antimicrobial and antifungal properties that fill the micro spaces and voids around aggregate or in block. This hydro-gel permanently seals the matrix blocking water, vapor, or contaminant movement at 50–100 square-foot per gallon (1.2–2.5 m² per liter).

“We spray applied the Protect AM-PT-BW using a high-volume, low-pressure sprayer. This layer is extremely important because if there should ever be a breach of the coating system, the wall surface will still have antimicrobial properties,” explained Puszynski. The Protect AM-PT-BW is specially formulated for walls, as it is more viscous than its floor counterpart.

After waiting 24 hours and allowing the material to fully penetrate into the concrete walls, the crew was ready to apply the Protect 1200 AM-WR primer. This antimicrobial two-component, water-reducible epoxy primer was applied with rollers at a thickness of 5–6 mils (127.0–152.4 microns). “After the primer had cured — about two hours — it was time for the application of Protect 1000 AM, an epoxy resin filler. This material was flat troweled on in two coats. It is used like spackle to fill irregularities and level out the substrate,” said Puszynski, who added that, although the thickness will vary, it averaged 30 mils (762.0 microns) per layer. This epoxy resin was applied over the course of two days, and according to Puszynski, the goal was to create walls that were like a sheet of glass: easy to clean and sanitize and free from imperfections that can catch dirt or other contaminants.

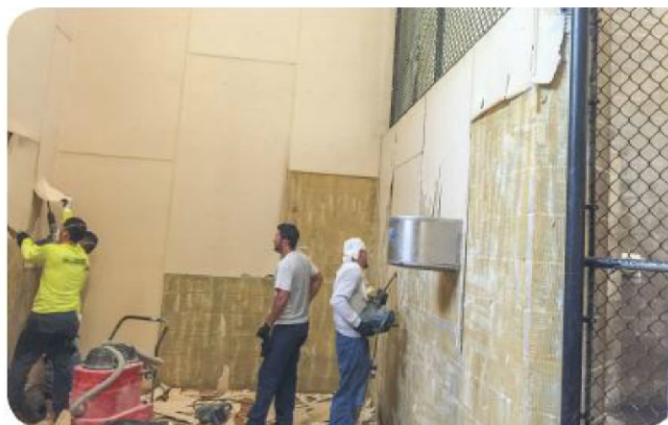
Because of the heights of the enclosures, the crew needed to use scissor lifts at times. They also wore dust masks, safety shoes, safety glasses, and Tyvek protective suits, when necessary.

With the PIP antimicrobial coatings chosen for the job, it was time for the Concare team to get to work on the indoor enclosure space. The first order of business was to remove the FRP wall covering and the mastic underneath. "Obviously, the walls of the exhibit are very tall to accommodate the giraffes. We used Skyjack scissor lifts to access the highest areas," said Puszynski. These lifts have barricades on all sides,

so fall protection was not necessary while crew members were on the lifts; however, extreme caution was exercised at all times.

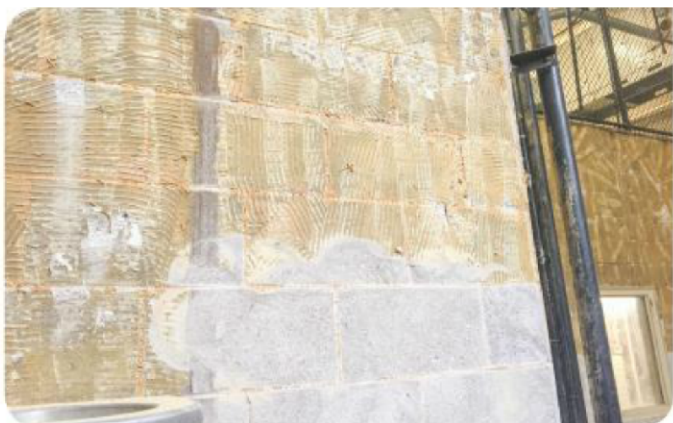
To the walls' 5,620 square feet (522.1 m²), the crew removed the old system using grinders. In total, the crew completed the repair and coating of walls and floors over the course of eight days.
