## Project Profile: Portillo's Commissary

*When food created a mess at Portillo's, Concare delivered a clean, safe flooring solution.*

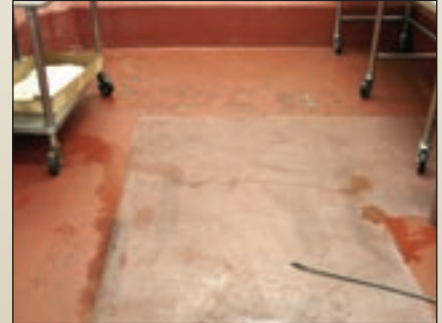
Years of spilled grease, continuous wash downs and damage from heavy cookware left the floors in the Portillo's Aurora Commissary in poor shape.

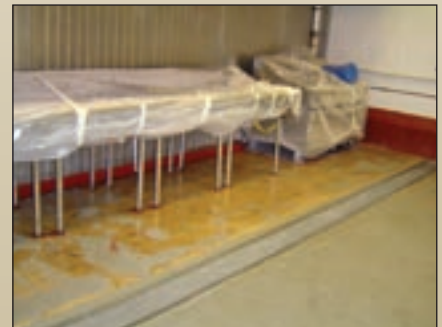
With little downtime to make repairs meant it was crucial to select the right material technology.

Concare's GuardRight MM (methylmethacrylate) flooring system was selected for its rapid cure time, among many reasons. The management at Portillo's was sensitive to the limited downtime available to make repairs, so it was crucial to select a flooring system that could be restored and back in service overnight. Supplementary trowelled ColorQuartz created impact resistance and added a decorative flair.

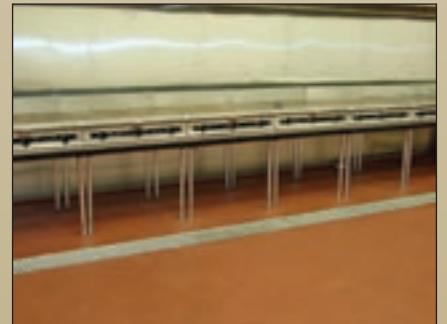
The rapid-curing GuardRight MM flooring system was installed overnight and the floor was back in service the next morning.
