Project Profile: The Pub at the University of Chicago

A historic hangout gets a much-needed sprucing up thanks to Concare, Inc.

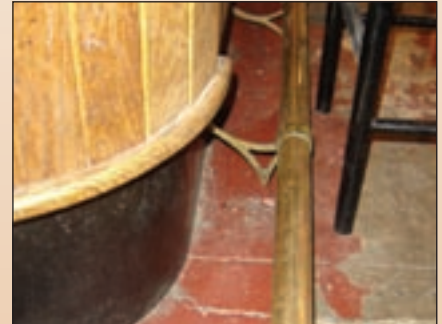
Years of high traffic made the current floor almost impossible to clean.

The Concare team discovered that The Pub's existing concrete was old and heavily cracked from years of high traffic, which made it nearly impossible to clean. Decades of soaked-in spills on a sub-grade slab and the floor's dark color made the space dingy and uninviting. The concrete also had depth variations from 3 to 5 inches and, due to its age, lacked a moisture barrier.

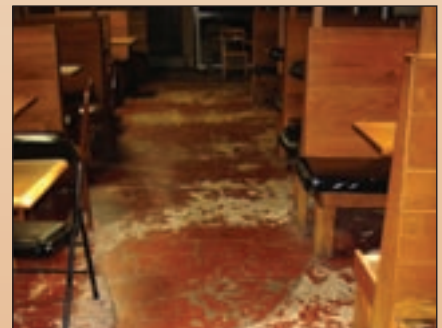
Deep cracks, odor issues and a dim, dank atmosphere led to a massive flooring renovation at The Pub.

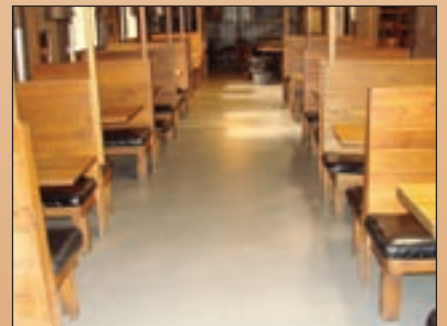
A remarkable transformation with the GuardRight EC-CQ system, delivered by Concare, Inc.

The Concare team began by surface grinding to preserve the concrete's remaining integrity and to prevent creating more damage. Then they applied fiberglass in areas with the highest concentration of cracking, providing the concrete with hidden durability. The system's light gray color brightened the space and ColorQuartz provided decorative strength. The system application was finished with a high-wear urethane in a satin finish to prevent premature wear.
